Reading Thermal SCORPION[®] 2 Case Studies: Clogged Air Knife

Clogged Air Knife

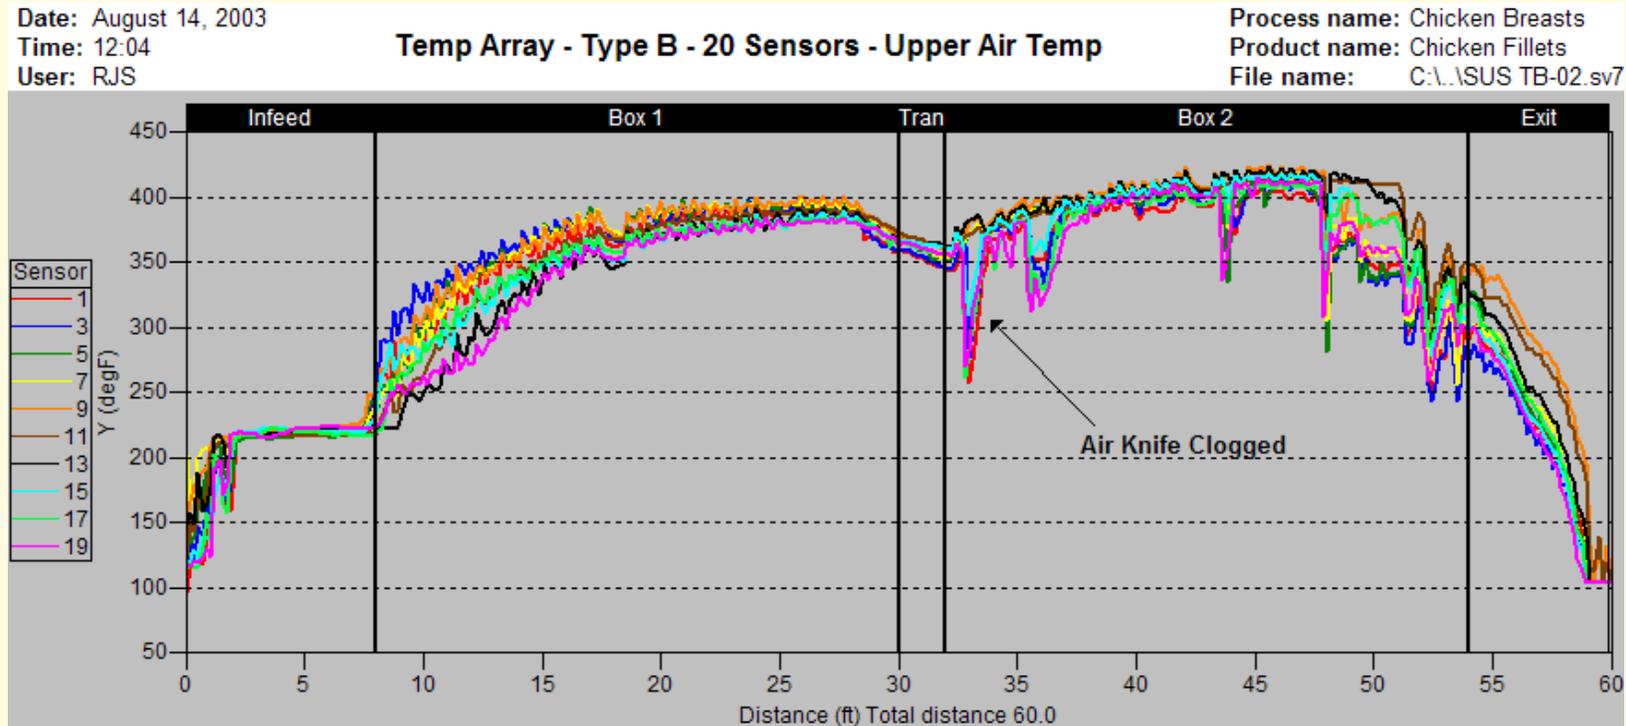
Analysis: Temperature profiling reveals large temperature drops ($>100^{\circ}\text{F}$) across the band at 32ft into the process, just inside the entrance of Heat Box 2.

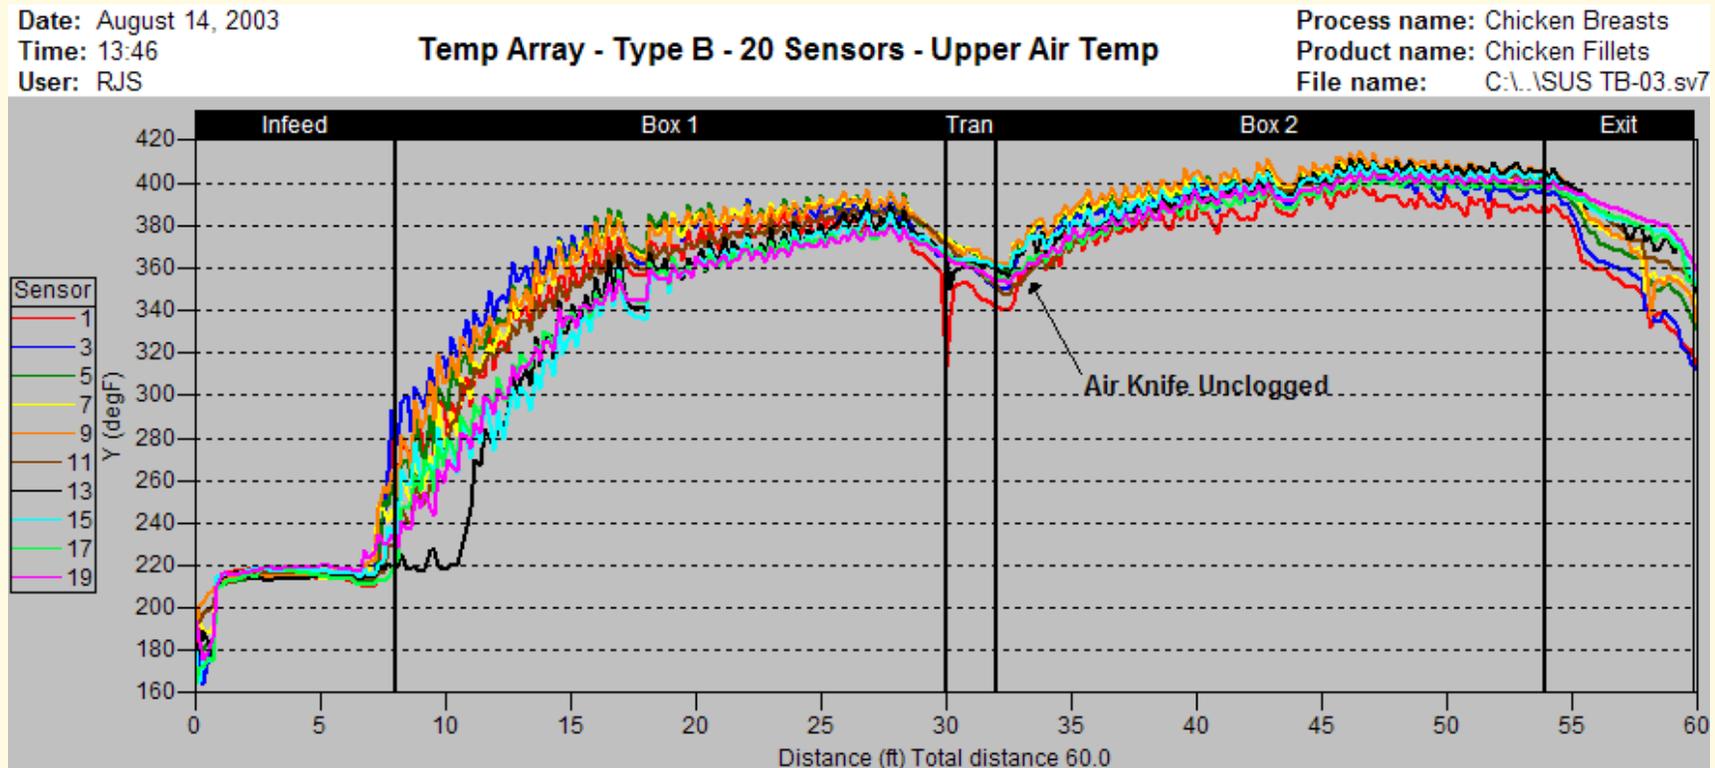
Solution: Physical inspection revealed that an air knife was clogged with product debris. The clog occurs after 2-3 hours of production.

Air knife cleaned and unclogged.
