# SCORPION<sup>®</sup> Case Study: Clogged Air Knife

# Clogged Air Knife

**Product:** Chicken Breast Fillets

**Plant:** Chicken Processor - Southern U.S.

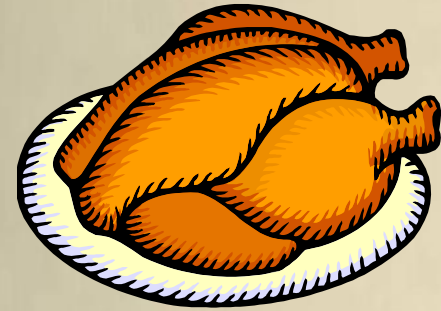
**Problem:** The company is having trouble producing chicken fillets with a consistent bake, causing low yields. A side-to-side and over-time variation in bake occurs sporadically during production runs.
