SCORPION[®] Case Study: Clogged Air Knife

Clogged Air Knife

Product: Chicken Breast Fillets

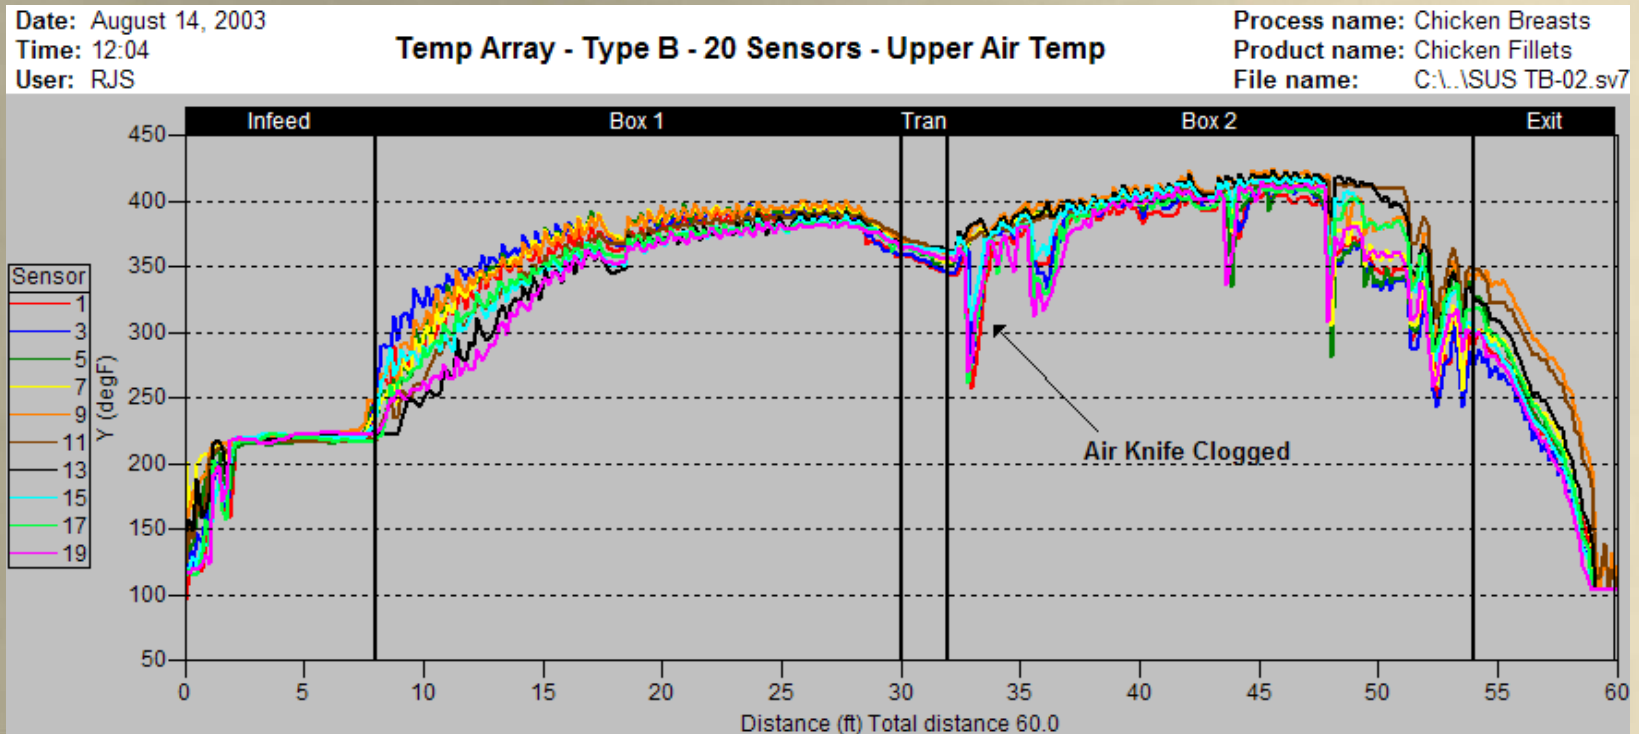
Problem: The company is having trouble producing chicken fillets with a consistent bake, causing low yields. A side-to-side and over-time variation in bake occurs sporadically during production runs.

Analysis: Temperature profiling reveals large temperature drops ($>100^{\circ}\text{F}$) across the band at 32ft into the process, just inside the entrance of Heat Box 2.

Solution: Physical inspection revealed that an air knife was clogged with product debris. The clog occurs after 2-3 hours of production.
